Technical Memorandum

2012/13 Fish Utilization Report

Maxwelton Watershed

Regarding: Maxwelton Watershed Spawning Survey and Smolt Count, performed by Whidbey Watershed Stewards

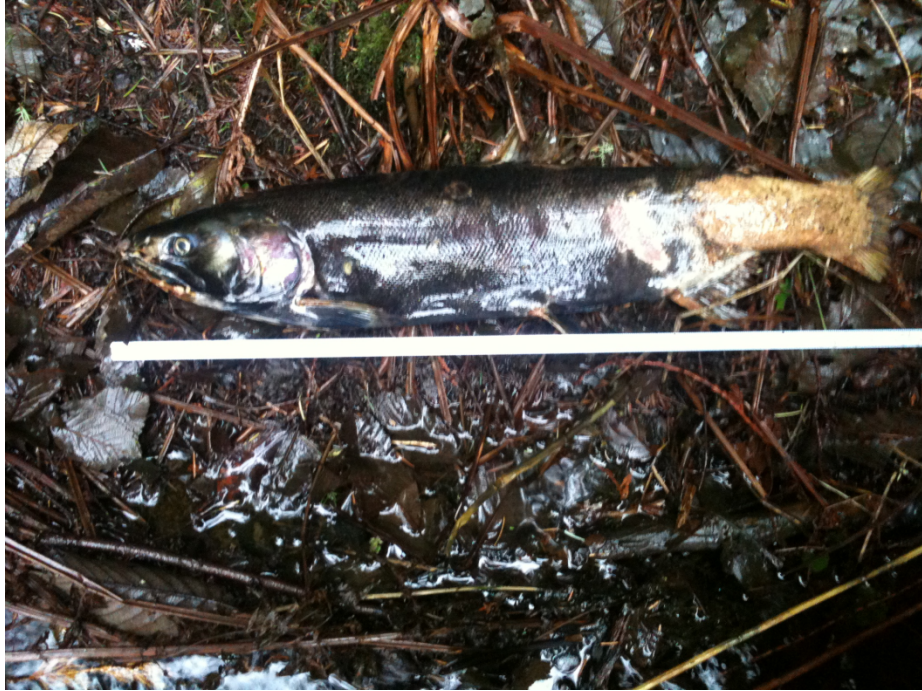
Figure 3: spawned salmon from Maxwellton Creek 12/15/13

This survey was also conducted on a cloudy, but rainless day. The gauge reading was at 1.9', a high flow situation which makes visibility and surveying difficult. This is approximately bank full height. Temperature was noted at 41 degrees Fahrenheit, although variation in thermometer readings was suspected. A second spawned out female carcass was found just upstream of the first one, in the location where the culvert had been removed in 2010. Again, no redds were evident and no male carcasses were found, but there were only a few eggs remaining in the carcass.

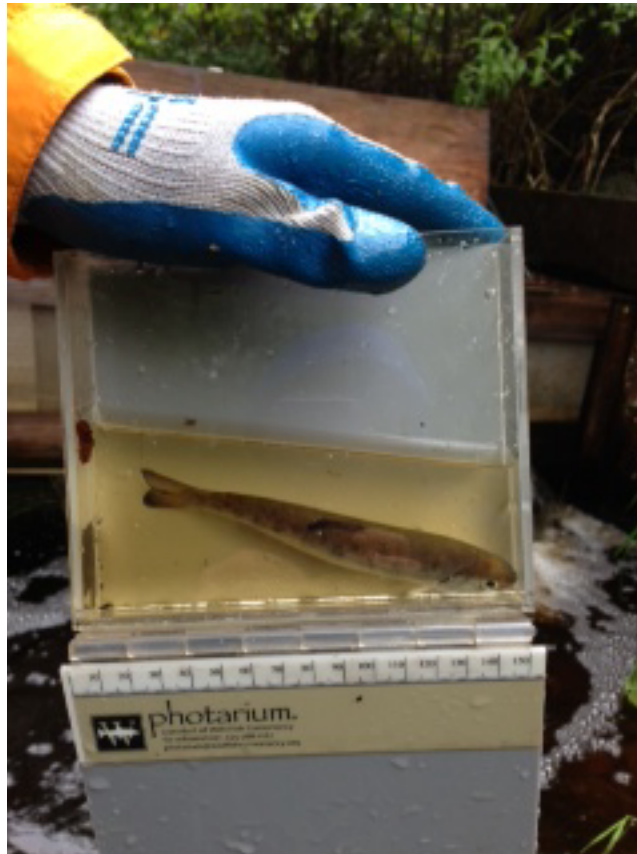
Figure 4: Smolt photo by WWS volunteer
